UMEÅ UNIVERSITY MEDICAL DISSERTATIONS

OCCUPANT CASUALTIES IN BUS AND COACH TRAFFIC

-Injury and crash mechanisms

Pontus Albertsson

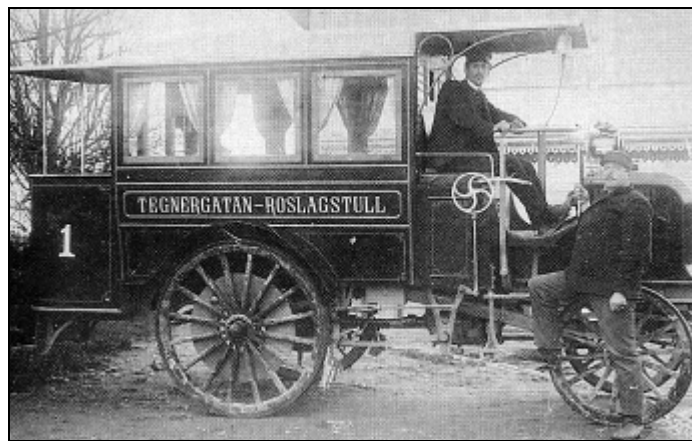
Figure 1. The first motor omnibus in Stockholm 1899 with iron-shod timber wheels. Photo from the Nordic Museum archives.

The first motor omnibus used in Stockholm came into use in 1899 (Figure 1) but was taken out of use after eight days because of the noise from the iron-shod timber wheels and it was not until 1923 motor buses were operating in the capital's streets again. At that time manufacturers in many countries started to understand the potential of the motor-car. The first two Swedish manufacturers in the automotive industry were Vagnfabriken and Scania (Nordström & Nyström, 1990). Later on, Volvo became another participant in the Swedish omnibus market.

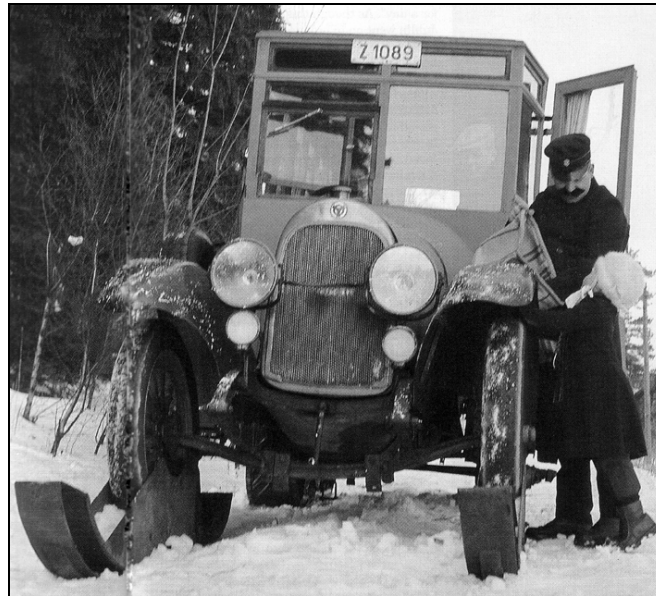
Figure 2. The first Scania-Vabis motor post bus in traffic 1922 between Lycksele and Tvåålund, Västerbotten, Sweden. Here equipped with skis on the front wheels. Photo from Gert Ekström's collection.

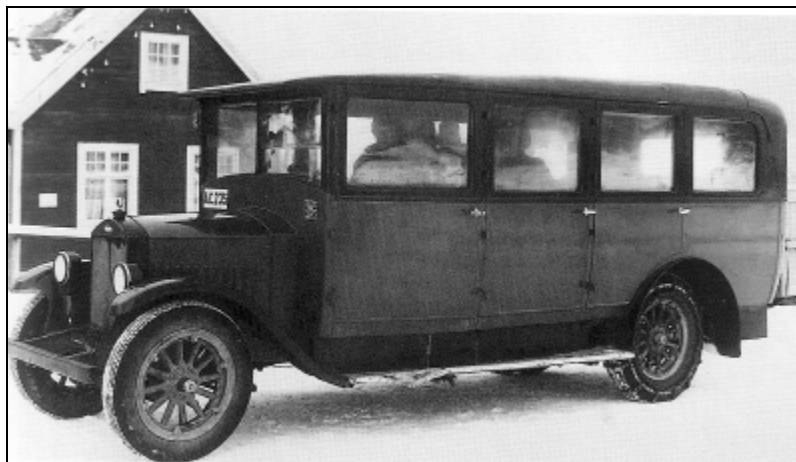
Figure 3. A common model of a four-cylinder Volvo bus built on a truck chassis from late nineteen twenties. Photo from Volvo central archives.

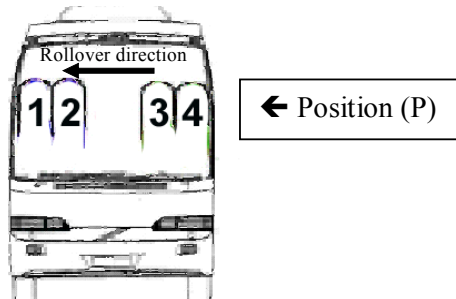
Figure 7. Identification of the occupants' position (1-4) in the coach in relation to the rollover direction.

The occupants' lateral positions in the coach were categorised as Position 1 - 4, (P1-P4) as shown in Figure 7.

Position 1 in Figure 7, indicates that the occupant was seated next to the rollover side window. Position 2, in turn, indicates that the occupant was seated next to the rollover side's aisle. Position 3 indicates that the occupant was seated next to the opposite side aisle and position 4 indicates that the occupant was seated next to the opposite side window.

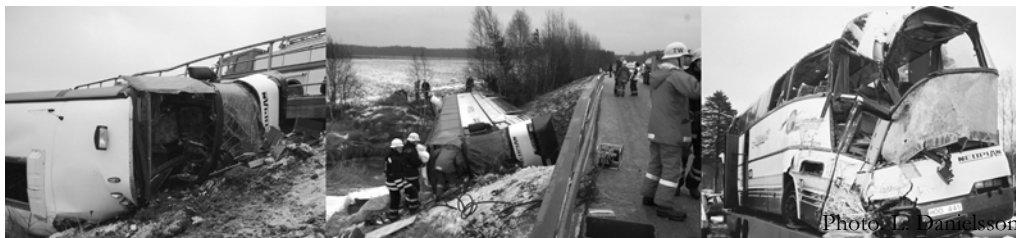
Figure 9. The front of the coach after the impact to the river bank.

The coach went off a road via a guard-rail and landed on the right side, after a 90° rollover position right across a small river. The impact from the crash was greatest in the frontal part of the coach since this part fell three metres from the bridge guard-rail down to the river bank as shown in Figure 9. The rear part of the coach slides on the river bank with less impact as a result.

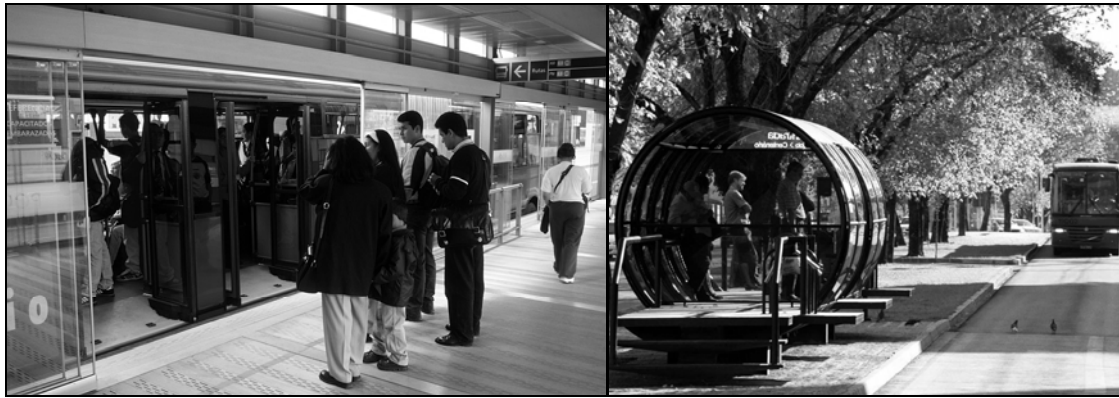
Figure 10. The Volvo built system in Curitiba Brazil facilitating boarding and alighting.

When further exploring possible safety enhancement measures it can be noticed that the outstanding non-crash event injury mechanism in Paper I was alighting, a finding confirmed by other studies, see, for example; Kirk et al. (2001), Kirk et al. (2003), SAMIS, (1995) and Skjoth-Rasmussen & Rasmussen, (1999). Actually, alighting injuries rendered MAIS 2+ injuries in almost half of the cases. Furthermore, slipping due to low friction was claimed to be the reason in more than half of the cases. City-buses with kneeling fronts and sides, in combination with the above described wintertime measures, might prevent this type of injuries. Another example is the Volvo system implemented in Curitiba Brazil and other cities in South America that facilitates boarding and alighting by having the bus floor and the embark area at the same levels (Figure 10).

Another advantage with this system is that the ticket is registered at a ticket barrier on the bus stop, instead of inside the bus which contributes to shorter passenger travelling and waiting time, and perhaps less incidents since the passengers can concentrate on entering the bus instead of handling the ticket.

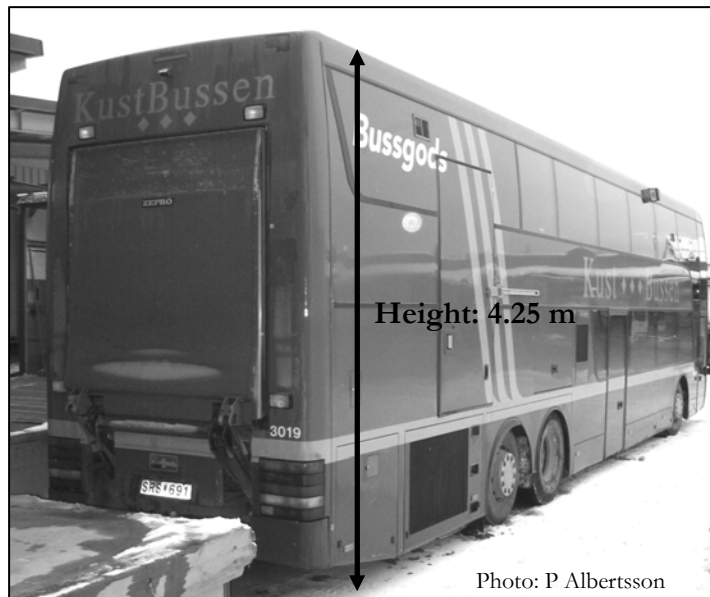
Figure 11. A double-deck vehicle with rear baggage and goods compartment. This type of coach is used for combined transport of passengers and goods in rural areas in Sweden.

double-deck vehicle may be 60-80 centimetres higher than a corresponding single-deck vehicle (Figure 11).

In case of a rollover with a double-deck vehicle, the greater distance from the centre of gravity in the upper compartment the greater increase of the rotation velocity. This, in turn, will increase the impact with greater risk for injuries as a consequence. A study by Botto & Got (1996) supports this statement. The study showed that if the coach had an upper and a lower compartment, more than 80% of the KSI was located in the upper section of the coach. Additional risk factors for these coaches may be hitting low bridges and low positioned road signs (Swedish Television, 1996), and the risk for direction instability due to cross-winds (Juhlin, 2003).
